NASA Technical Paper 1210

Light Airplane Crash Tests at Three Flight-Path Angles

Claude B. Castle and Emilio Alfaro-Bou

JUNE 1978

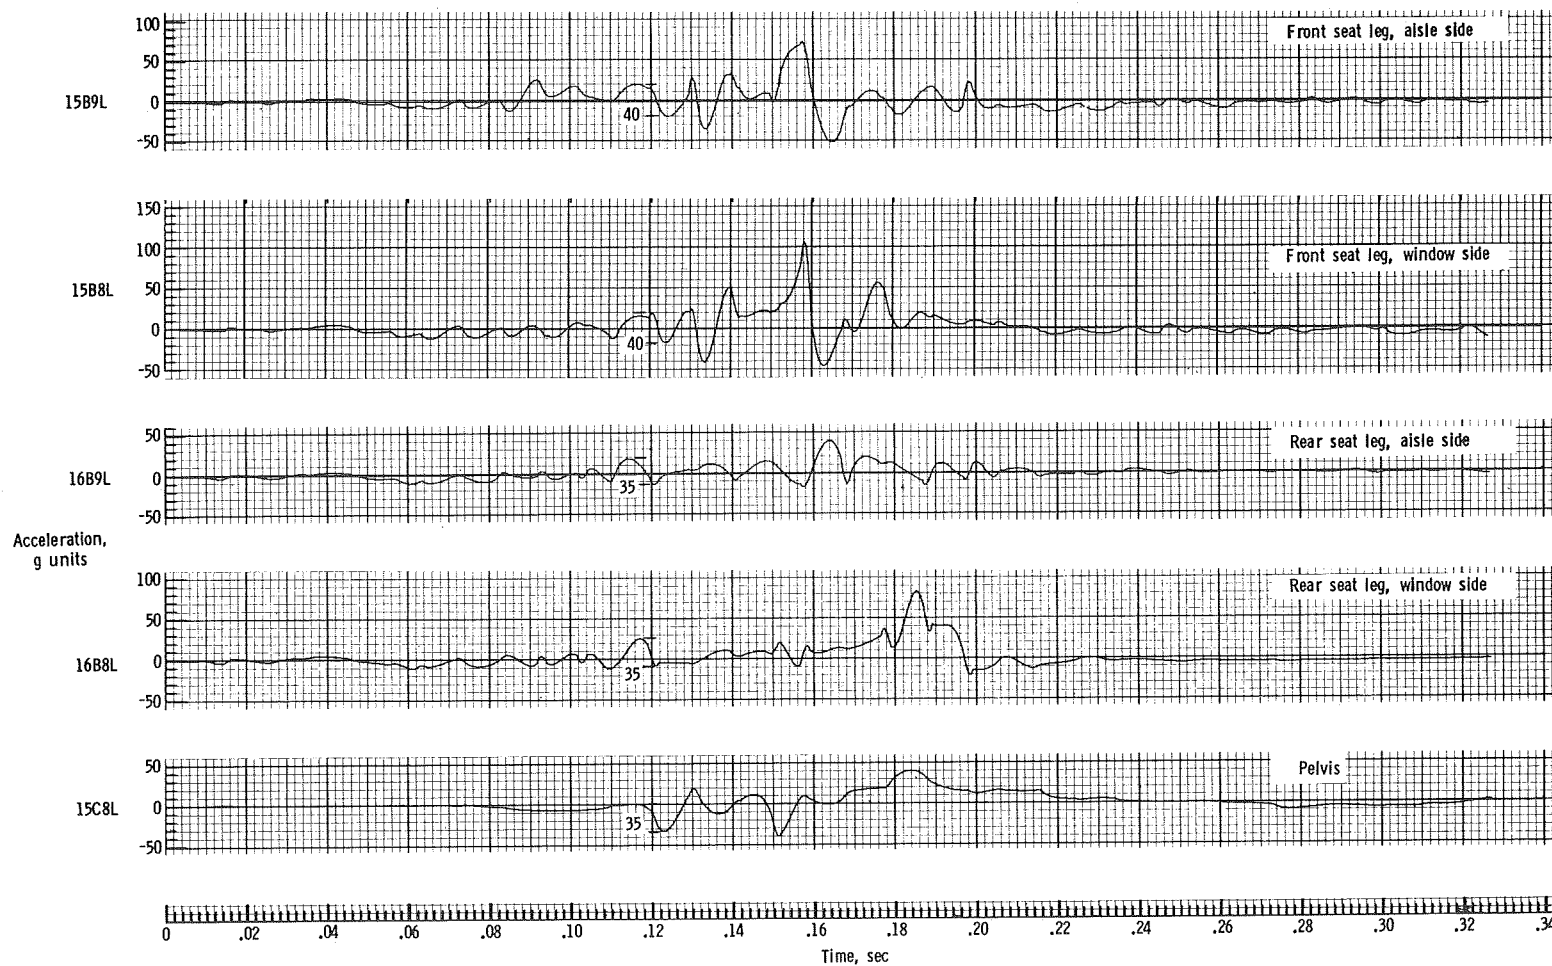
(c) -45° test specimen.

Longitudinal accelerations at -45° .— As shown for the -45° test specimen in figure 22(c), longitudinal peak-to-peak accelerations adjacent to each of the four seat legs were approximately the same: 40g for the two front legs and 35g for the two rear seat legs. The pelvis also experienced the same value as the two rear legs of 35g occurring 0.025 sec later.

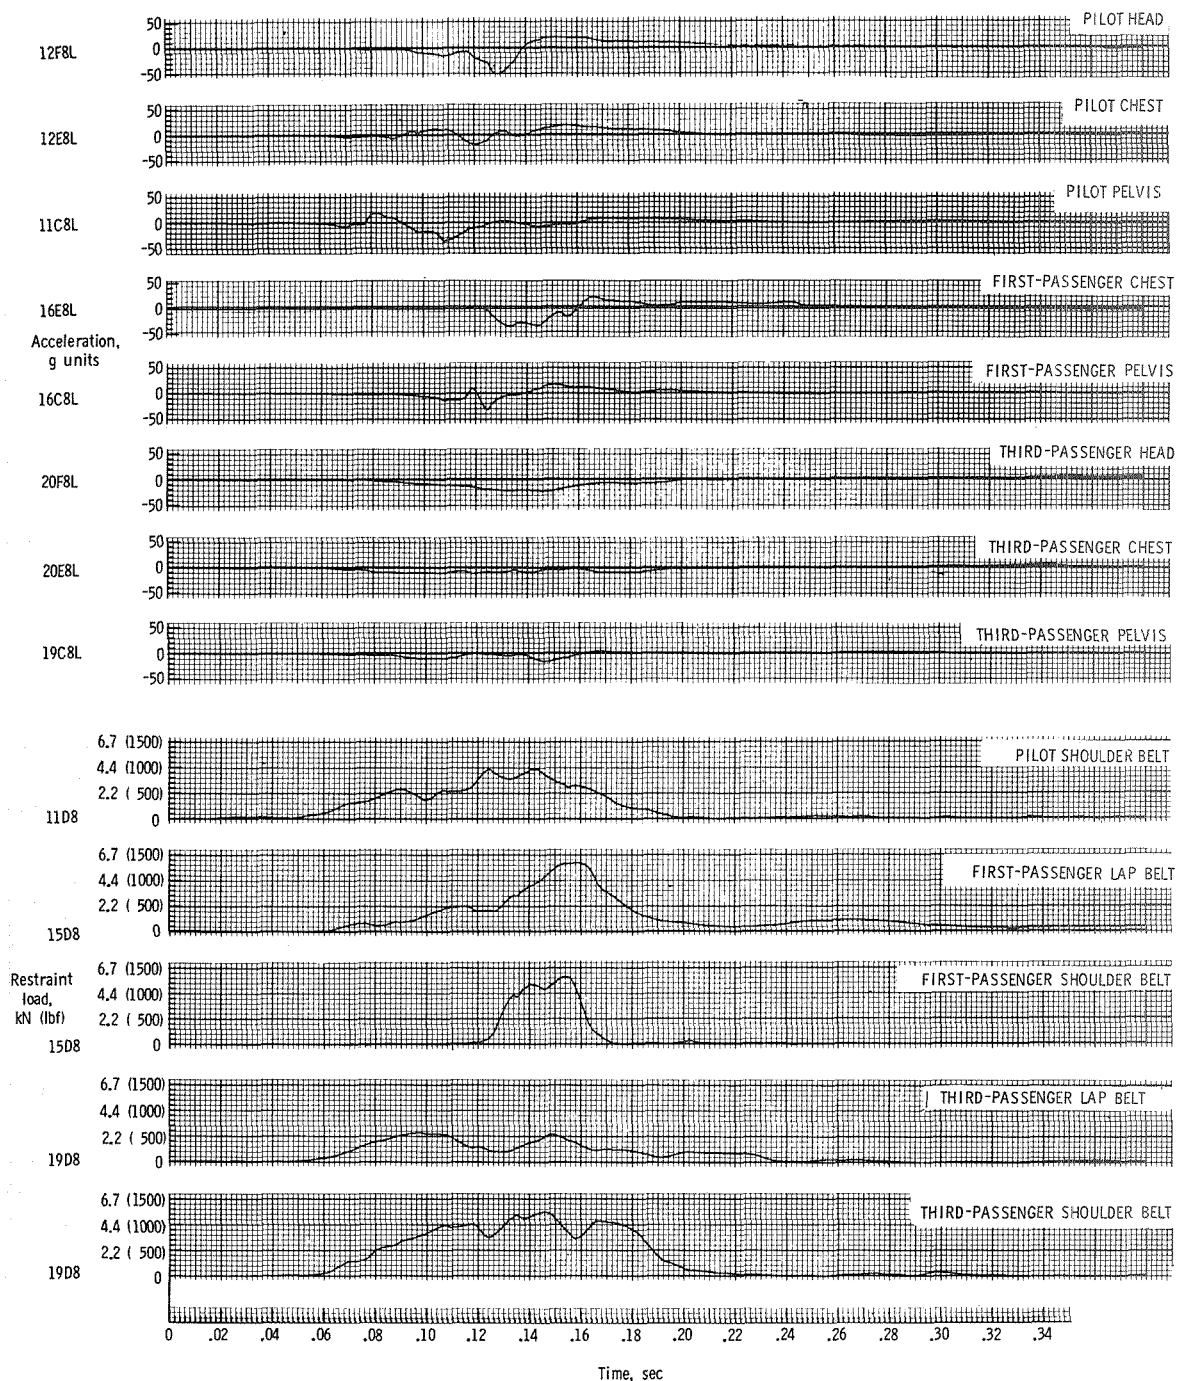
(f) Longitudinal accelerations in dummies and restraint system.

The -30° test specimen was the only one in which the restraint system of the first passenger was instrumented with load cells. The positive (downward) peak-to-peak accelerations of 60g (fig. 21(b)) in the pelvis corresponded to a 5.3-kN tensile force in the shoulder harness (see appendix fig. A3(f)) when the occupant's relative motion with respect to the seat was stopped by the restraint system.
